Category D	Repair Guidance	Ref No. R041/96	Page 1 of 3
Coverage <input type="checkbox"/> Distributor only <input checked="" type="checkbox"/> Please inform to your dealers		Date issued August 26, 1996	
Please convey this information to your <input type="checkbox"/> Director <input type="checkbox"/> General Manager <input checked="" type="checkbox"/> Warranty Dept. <input checked="" type="checkbox"/> Parts Dept. <input checked="" type="checkbox"/> Training Dept. <input checked="" type="checkbox"/> Field Rep		Date Revised	
Applied Model 626/MX-6(GE) with FP, FS engine		Applied Country or Specification Worldwide

Subject: **HLA Noise at Idling**

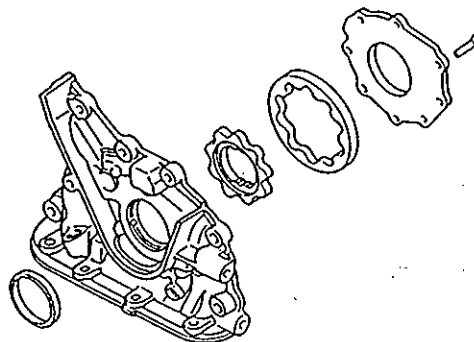
Oil Pump

The oil pump control plunger is worn excessively, and this causes air to be sucked up into the oil pump. The air bubbles are delivered to the HLA, resulting in the noise.

When you encounter a customer complaint of this concern, replace the control plunger with a modified one.

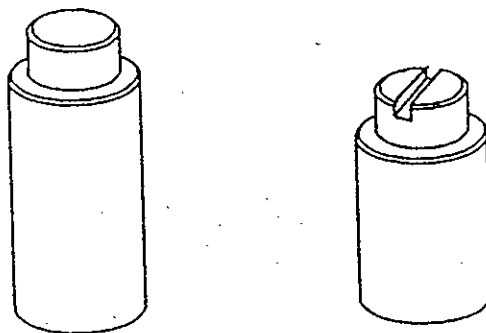
Control Plunger

1. Surface treatment has been added to the control plunger to prevent excessive wear.
2. A slit has been added to the top of the plunger so that the plunger operates within its specified oil pressure.
